Out-of-Service Corrosion Failure of Horizontal Downcomer, Supply, and Riser Pressure Part Connections

PSB2-83 was issued on November 15, 1983 to provide awareness of the corrosion failure of horizontal downcomer, supply, and riser pressure part connections. In the seven years since PSB2-83 was issued, new data has been obtained requiring revision of the previously released information.

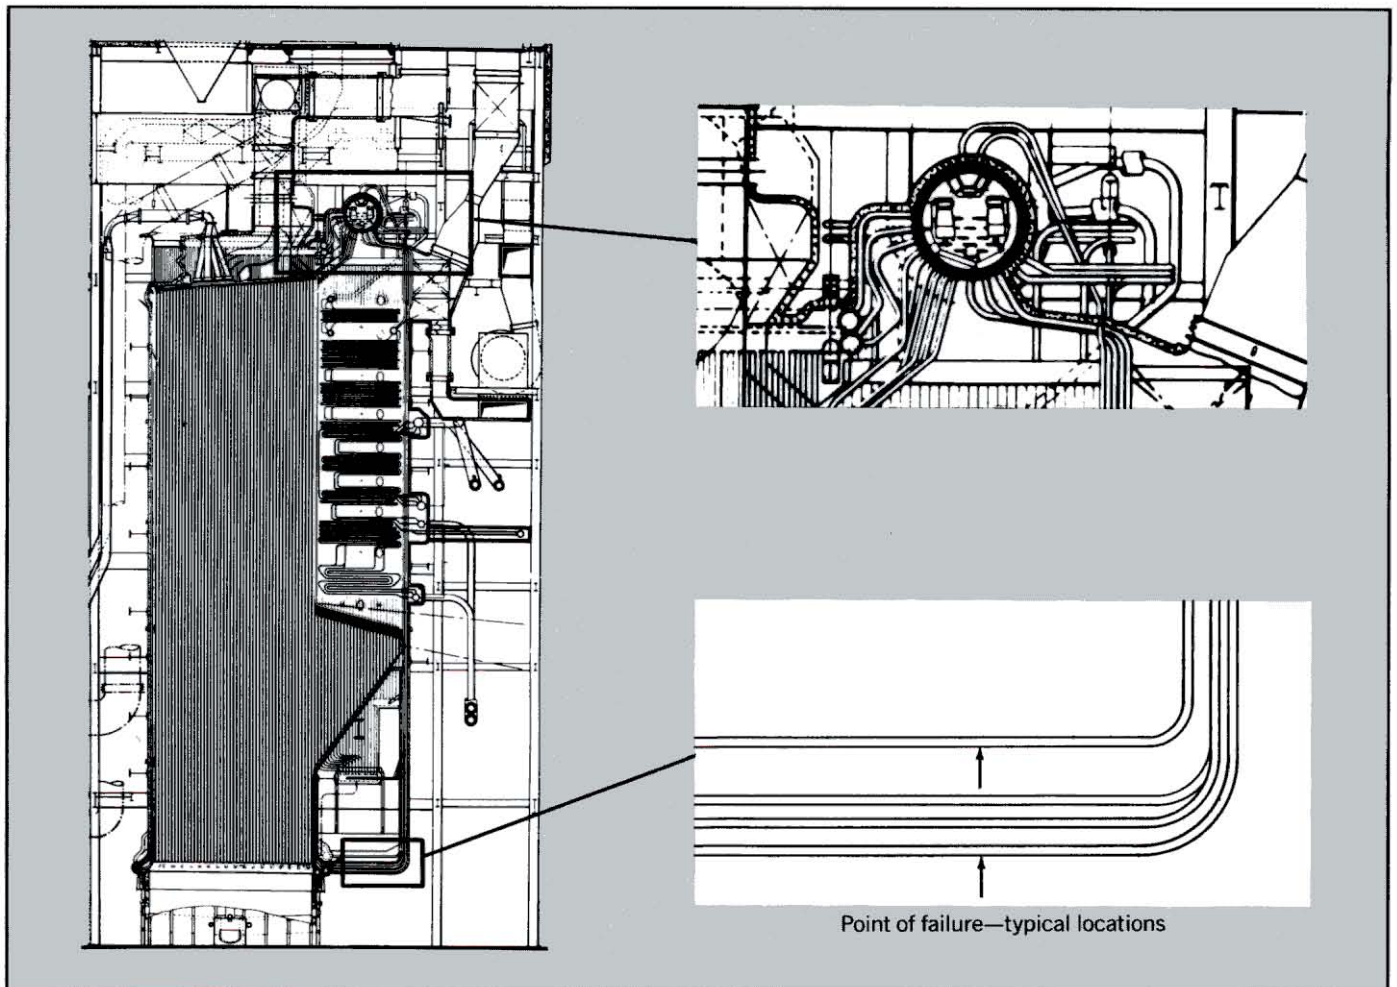
In 1983, a failure occurred on a twenty-nine year

old B&W unit due to corrosion of a horizontal section on a downcomer tube. See Figure 1 for the location of the failure. The failed downcomer tube was a 4 in. O.D. x 0.340 in. minimum thickness tube, on a 1,300,000 lb/hr, 2,200 psig natural circulation boiler. Injury to personnel and the immediate loss of unit generation resulted from this failure as these tubes are external to the boiler setting.

Figure 1 Typical location for potential corrosion failure in horizontal tubes.

Corrosion to the point of failure in both cases was probably due to one or more of the following factors:

1. Inadequate flushing of the horizontal tubes after a chemical cleaning.
2. Out-of-service corrosion due to exposure to air and water.
3. Improper chemical cleaning, resulting in localized pitting (nine chemical cleanings were performed on the first unit in question, between 1958-1981).

B&W recommends inspecting areas that may not completely drain, such as those described above. Unfortunately, these areas are usually not easily

accessible for inspection, and require alternate examination methods such as ultrasonic flaw detection, radiography, fiber-optic inspection or tube sampling. There is usually no visible external sign that a tube is approaching failure.

Tubes with horizontal runs and especially those with sagging, non-drainable, low spots in the horizontal run should be inspected. Any reduction in the pressure part wall thickness must be evaluated with regard to safety and continued operation. Review maintenance and operating procedures to emphasize the importance of the following:

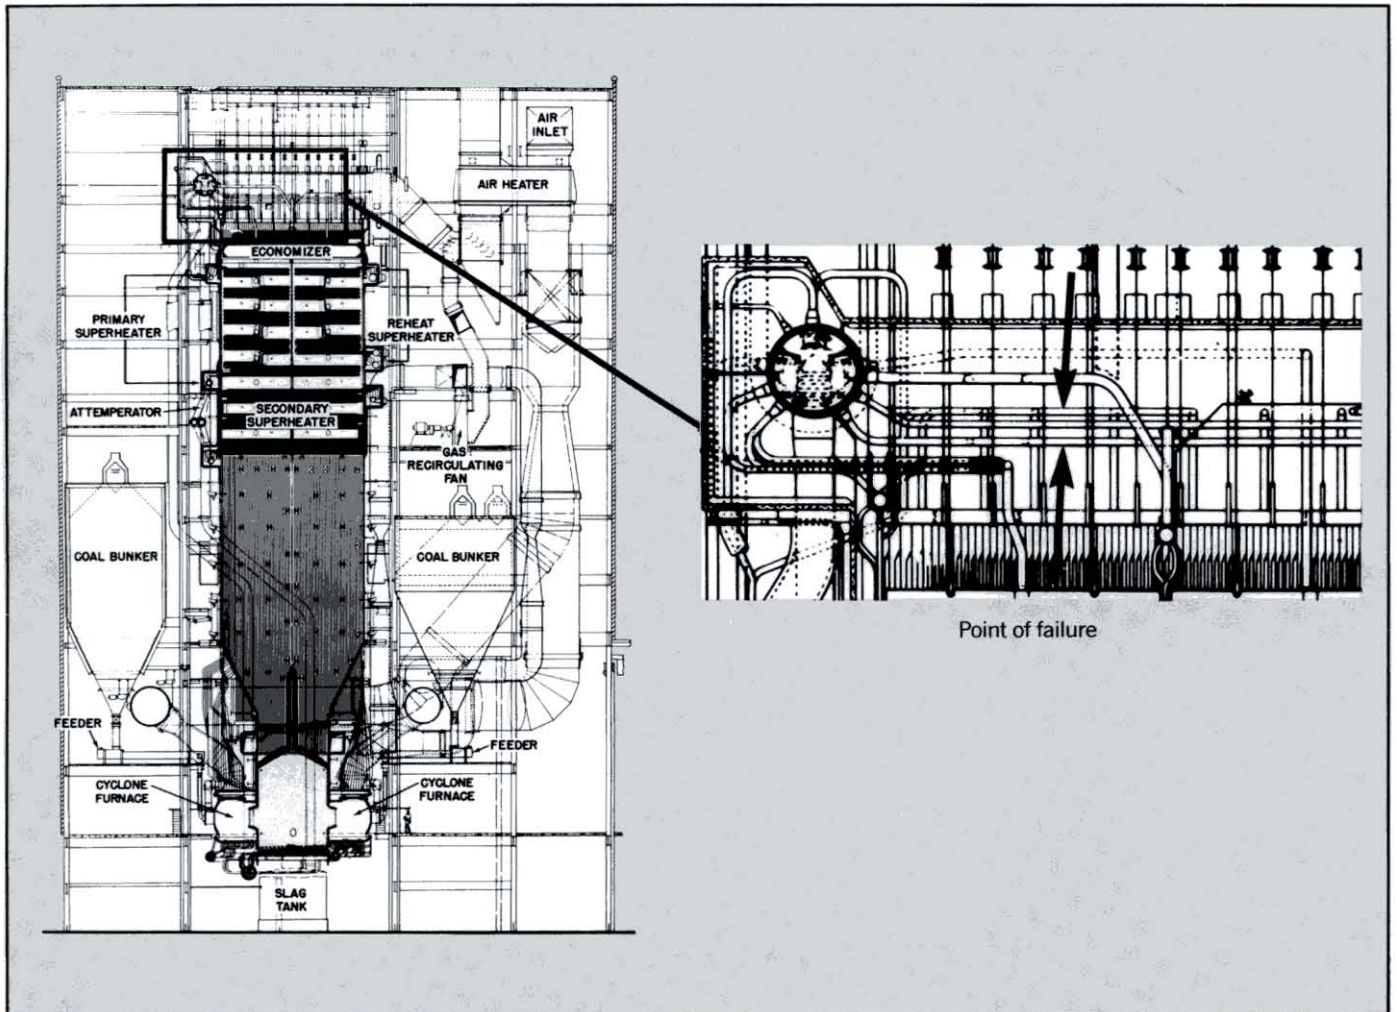
In January, 1987, a failure occurred on a 30-year old B&W "Tower" boiler. The failure was in a 6-5/8 in. O.D. x 0.562 in. minimum thickness

furnace sidewall riser tube on a 2,200,000 lb/hr natural circulation boiler operating at 2100 psig. See Figure 2 for the location of the failure.

Figure 2 Typical location for failures in furnace sidewall riser tubes.

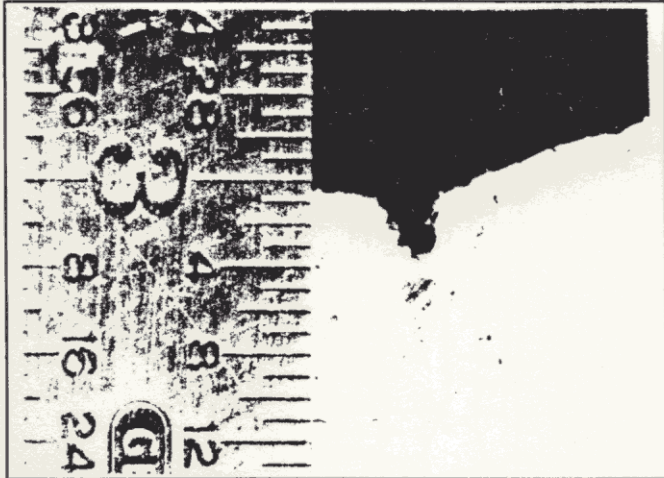
assure complete drainage. A residual "ribbon" of fluid can remain along the bottom of such tubes. When the unit is open to the atmosphere, air can interact with the residue and may result in corrosion. Corrosion may be aggravated during chemical cleaning, because the solvent can remain in a crevice and accelerate the pitting. Figures 3, 4 and 5 show the type of pitting and crevices that can be produced and can lead to failures.

The failures cited above had pitting between the 5 and 7 o'clock positions of the failed tube. Similar corrosion pitting has been present on other units that have been inspected.

Figure 3 Typical valley crevice.

1. When performing boiler chemical cleanings, thorough passivation of the cleaning solvents must be accomplished quickly, using procedures that will generate adequate mixing and reaction of the chemicals.

2. Flushing followed by internal inspection after chemical cleaning must be considered an important step in the procedure to assure solvents and sludge accumulations have been removed. Individual tube flushing with a water hose may be required to remove accumulations.

3. Wet storage with O_2 scavenging and inert blanketing with nitrogen should be used and carefully maintained during out-of-service periods. Freeze protection must be considered during winter months.

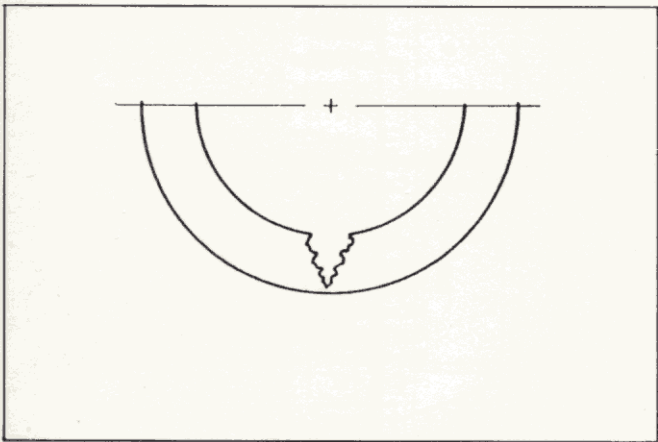
Figure 4 Crevice leading to failure.
