Creep Fatigue and Ligament Cracking of 1-1/4 Cr-1/2 Mo-Si (T11 and P11) Pressure Parts

Plant Service Bulletin PSB-1 was issued May 2, 1983 to provide awareness of creep swelling and ligament cracking of 1-1/4 Cr-1/2 Mo-Si (SA213-T11 and SA335-P11) Pressure Parts.

Since initial issue of PSB-1 in 1983, inspection recommendations and techniques have been updated, and the ASME Code has been revised. PSB-1A provides this updated information.

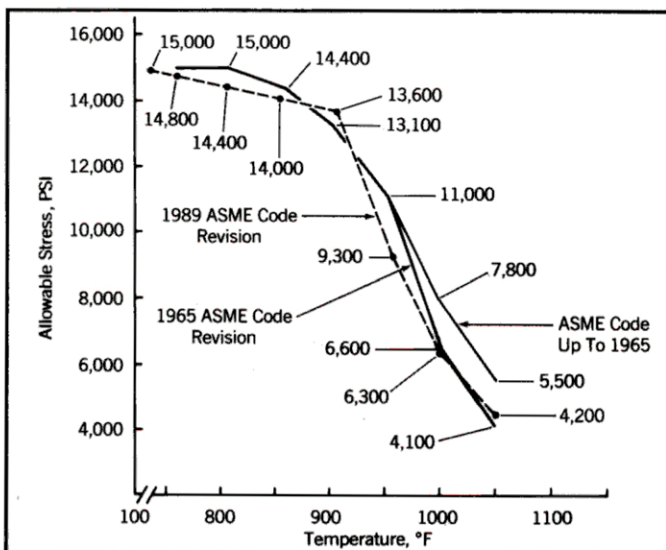
During this time frame, the ASME Code allowable stresses for 1-1/4 Cr-1/2 Mo-Si (T11 and P11) were based on a relatively small data base. During 1965 a larger data base became available and allowable stresses for this alloy were significantly reduced in the Summer 1965 addenda to the ASME

Code. With the 1989 addenda to the ASME Code, these stresses were further reduced at certain temperatures. See Figure 1 for these revisions.

Figure 1 Allowable stress versus temperature for 1-1/4 Cr-1/2 Mo-Si.

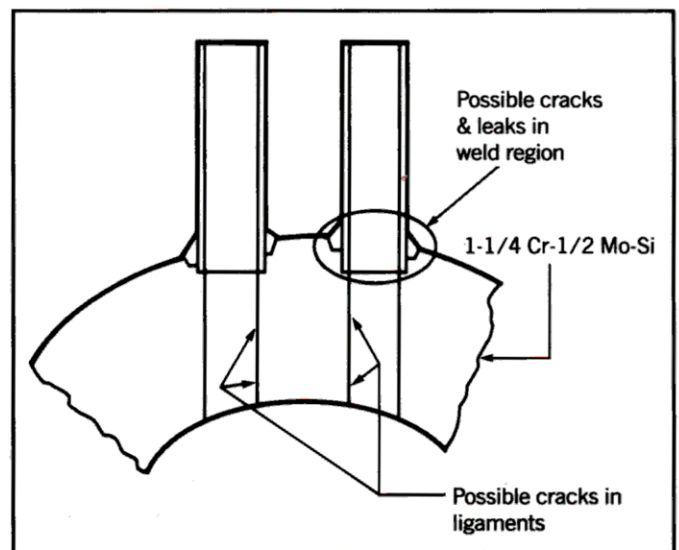
For simple geometries such as piping, the failure sequence may consist of minor swelling and crack initiation at high stress points. Complex geometries such as headers are more likely to experience failures as a result of creep fatigue. The complex mechanisms found to cause cracks in headers are a result of cyclic thermal stress coupled with creep. This creep fatigue occurs at the tube stub bore hole penetrations into the header, can be very localized, and is not necessarily accompanied by a measurable swelling. Cracks that start along the bore hole will eventually propagate through the wall. If undetected, the first signs of the problem will be the occurrence of leaks at the tube stub-to-header welds, at which time the header may already be at its end of life. (See Figure 2).

Figure 2 Typical header.

If cracking has occurred, or if the percentage change in diameter is greater than 1% (2% for piping), replacement with a redesigned component based on the current ASME Code allowable stresses must be considered. Even less diametrical strain can be indicative of end of life if most of the damage was due to fatigue and not creep. Thus, it is not recommended to rely solely on swell measurements to determine header condition.

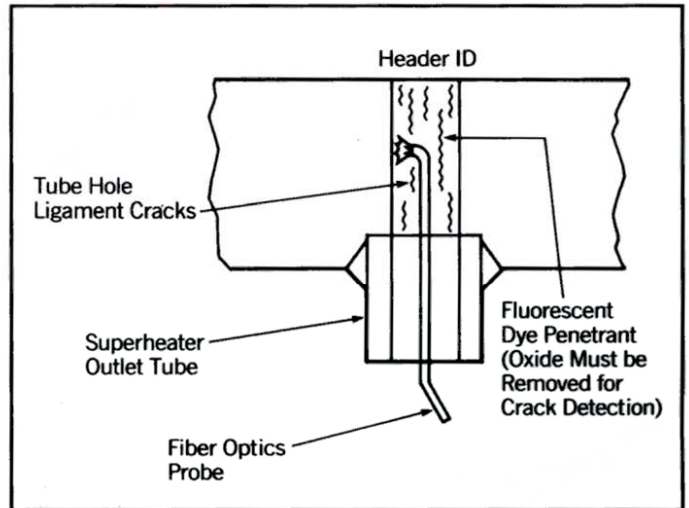
Items 1 and 3 are new techniques developed since 1983. Figure 3 shows how a tube bore hole examination is accomplished.

Exfoliation and cracking of high temperature oxides can hide or mask ligament cracks. Thus, it is **very critical** to remove these hard tightly adhering surface oxides from the tube hole region before conducting the internal dye-penetrant examination. A fiber optics or video probe examination is **inadequate** to locate cracking unless these oxides

Figure 3 Typical tube bore hole examination.

1. Internal fluorescent dye penetrant examinations of tube bores followed by deep penetrating eddy current sizing of cracks
2. External dye-penetrant testing of critical areas
3. Replications of select areas
4. Swelling measurements
