# Burners

To alert customers to known mechanical problems with burners and to provide recommendations for corrective action.

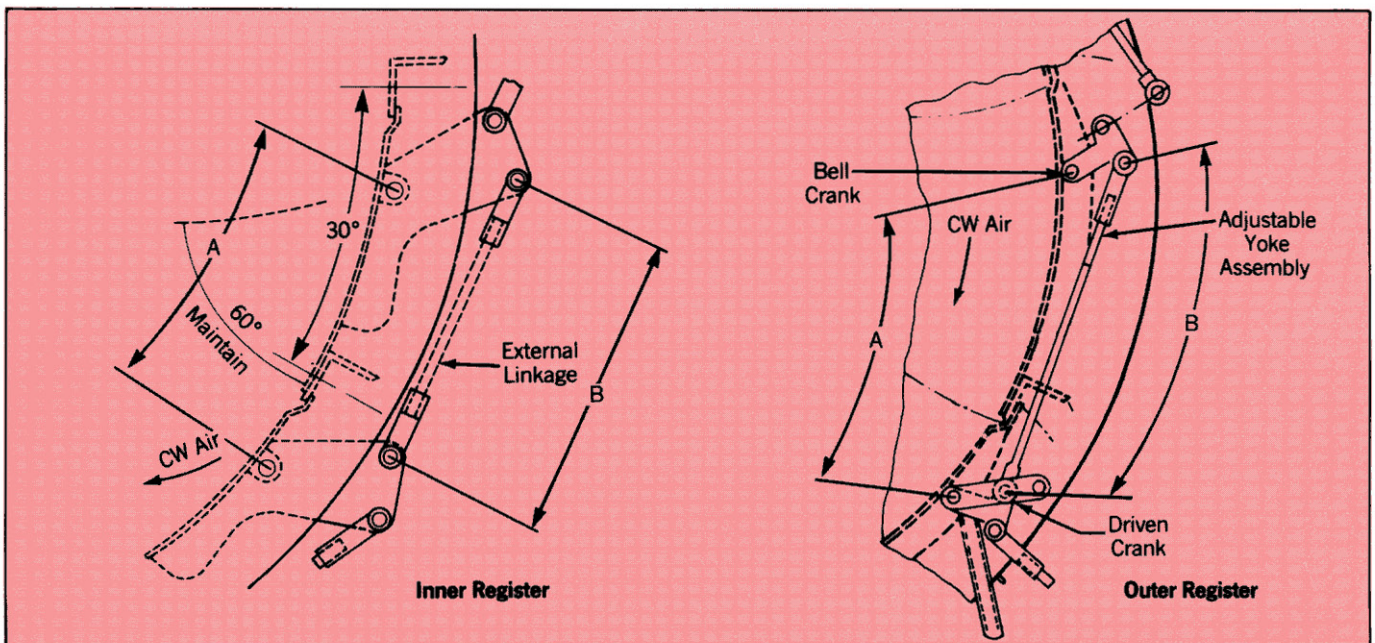
Figure 1 Inner and outer registers.

Register doors bind on Dual Register Burners.

Linkage is improperly adjusted.

Adjust register door linkage as follows: Adjust length of linkage (Figure 1) so that distance, center to center, between pins is equal to distance, center to center, of door shafts on linkage (distance A is equal to distance B). Distance between door shafts may vary with different blades.

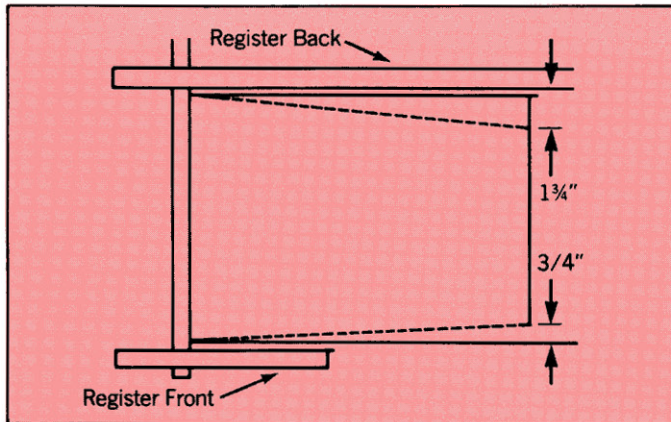
Figure 2 Typical register blade.

Front plate and/or back plate warping.

1. Trim register blade to clear front and/or back plate (Figure 2). Install thermocouples to set minimum cooling air.
2. Upgrade registers with H.D. register assembly for better reliability (Figure 3). An engineering review is recommended when a major modification is considered.

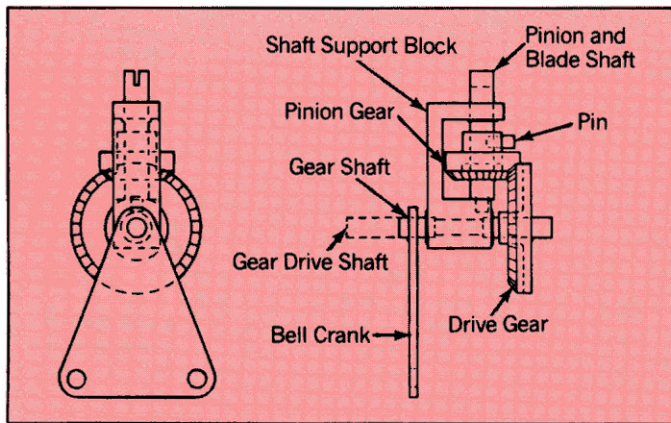
Figure 4 Coarser gear.

Spin vanes bind on Dual Register Burners

Ash is adhering to gear teeth.

1. Replace existing spin vane drive gears with new (coarse) design (Figure 4). This will minimize fly ash problem.
2. Do *not* use oil base lubricants on gears or register linkages. A graphite base lubricant is recommended, and only when necessary.

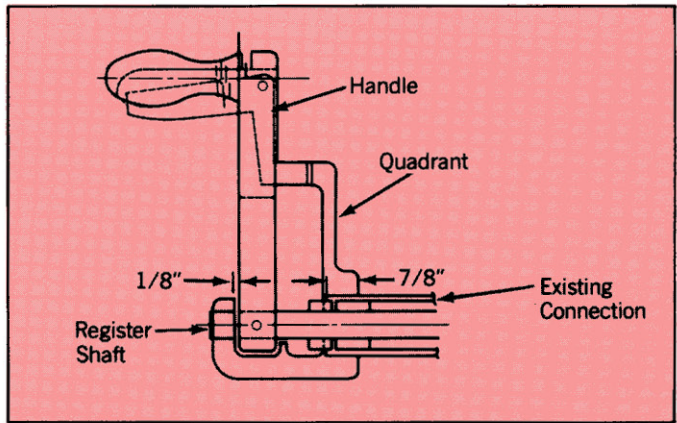
Figure 5 New quadrant.

Register position reference lost.

Quadrant unscrews from threaded connection on windbox.

Replace aluminum quadrant with cast steel quadrant (Figure 5). The cast steel quadrant slips over existing threads. Set register position reference and weld new quadrant to threaded wind box connection after matching actual register position with quadrant position.

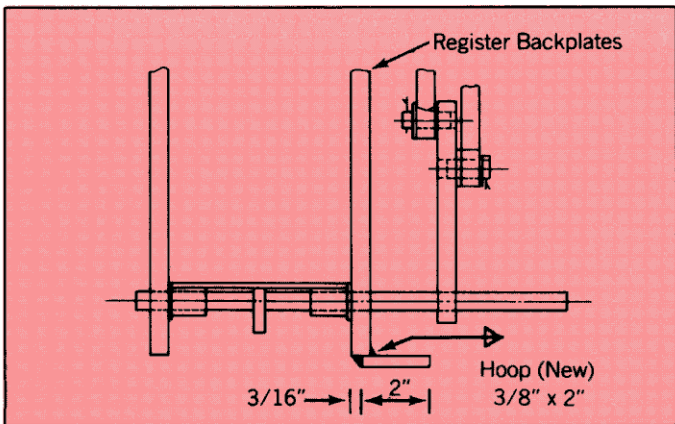
Figure 6 Typical repair for burner backplates.

Burner backplate overheats, distorts and warps.

When burners are out of service, cooling air may be insufficient to cool burner backplates

1. Straighten backplate and add a hoop to reinforce it (Figure 6).
2. Install permanent thermocouples on register and burner to determine if cooling air to out of service burner is adequate (Figure 7). Monitor thermocouples and adjust cooling air by using compartment dampers to keep burner cool.

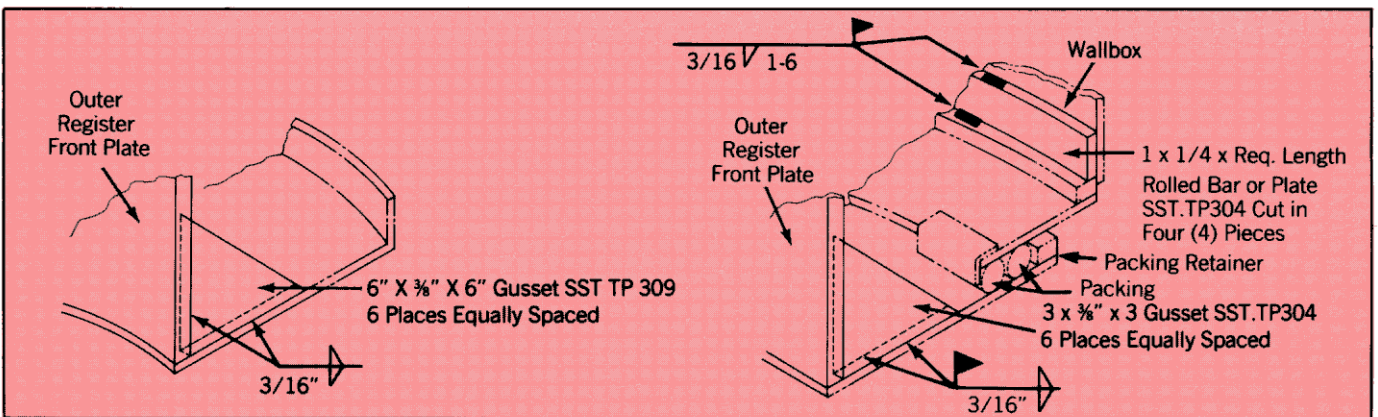
Figure 8 Slip seal plate modification (see Figure 7 for Location).

Air bypasses burner register assembly.

Register assembly warps. Front wall seal plate connection fills with debris and does not allow proper expansion movement.

Trim seal plate and add several rows of packing and a packing retained plate (Figure 8). Fiberfrax 2300 is recommended for packing. It retains its tensile strength while hot.
