## Pipe Thinning and Rupture

This plant service bulletin is a **SAFETY ALERT** that advises boiler owners and operators of the need to inspect condensate and feedwater piping, attemperation/desuperheater piping, and other auxiliary and branch piping where conditions conducive to flow accelerated corrosion may persist.

PSB-54A 1.5KDC8K

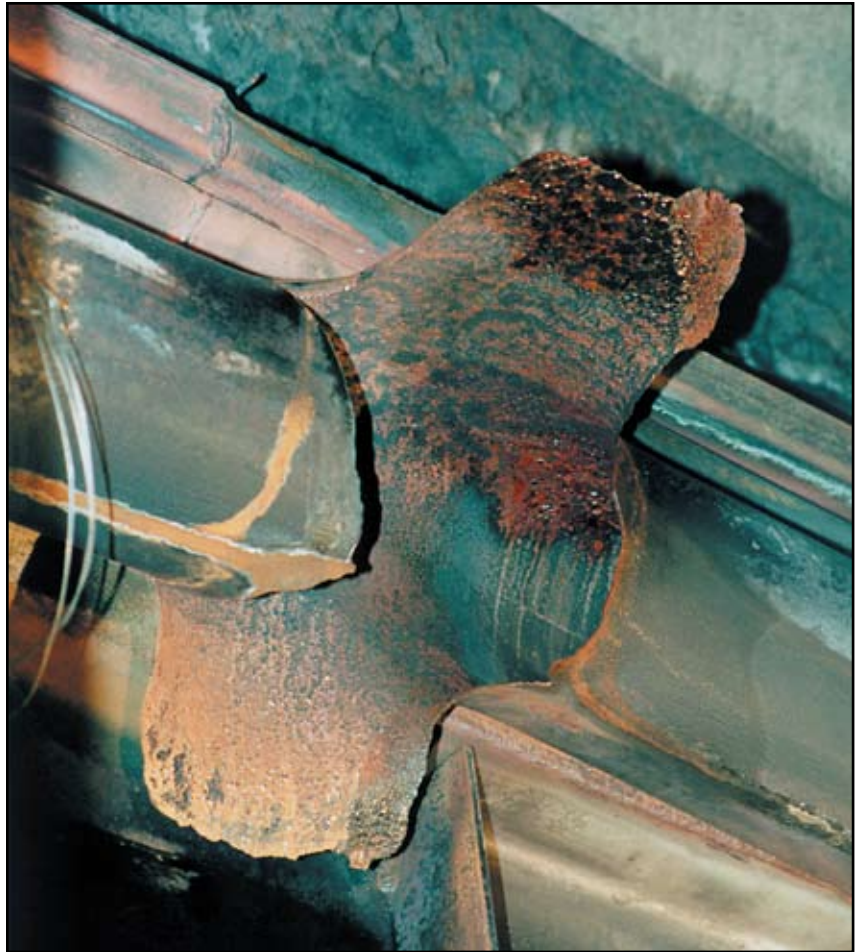
Internal thinning and subsequent rupture of carbon steel piping located outside the boiler setting remains a serious safety concern. B&W is aware of failures in recent years. Thinning generally occurs over months or years of operation. Ruptures can occur unexpectedly and close to work areas and walkways. Figure 1 is a photograph of a failure that fatally injured nearby workers.

Extensive research has led to an improved understanding of the failure mechanism. Pipe walls are thinned by localized dissolution of iron from the piping into flowing water. This is commonly referred to as flow accelerated corrosion. Steel is normally protected from corrosion by a surface layer of iron oxide. Thinning occurs where locally corrosive conditions destroy this normally protective oxide. For example, local chemical conditions may be sufficiently oxidizing to form soluble  $Fe^{2+}$  ions but not oxidizing enough to form or maintain  $Fe^{3+}$  ions needed for protective oxide formation.

Figure 1: Rupture of a six-inch (152.4 mm) feedwater pipe in an area thinned by internal corrosion.

**To assure continued integrity of all boiler feedwater and similar piping, it must be periodically inspected for internal corrosion and wall thinning. Any thinned**

**areas must be identified and replaced before they become a safety hazard.**

Where internal wall thinning has occurred, the affected pipe should be replaced with more corrosion resistant low-alloy chromium-bearing steel. Chromium extends the range of conditions under which surface oxide remains protective. Type SA-335 Grade P2
