# Economizer Hoppers

Advise customers to inspect economizer hopper supports.

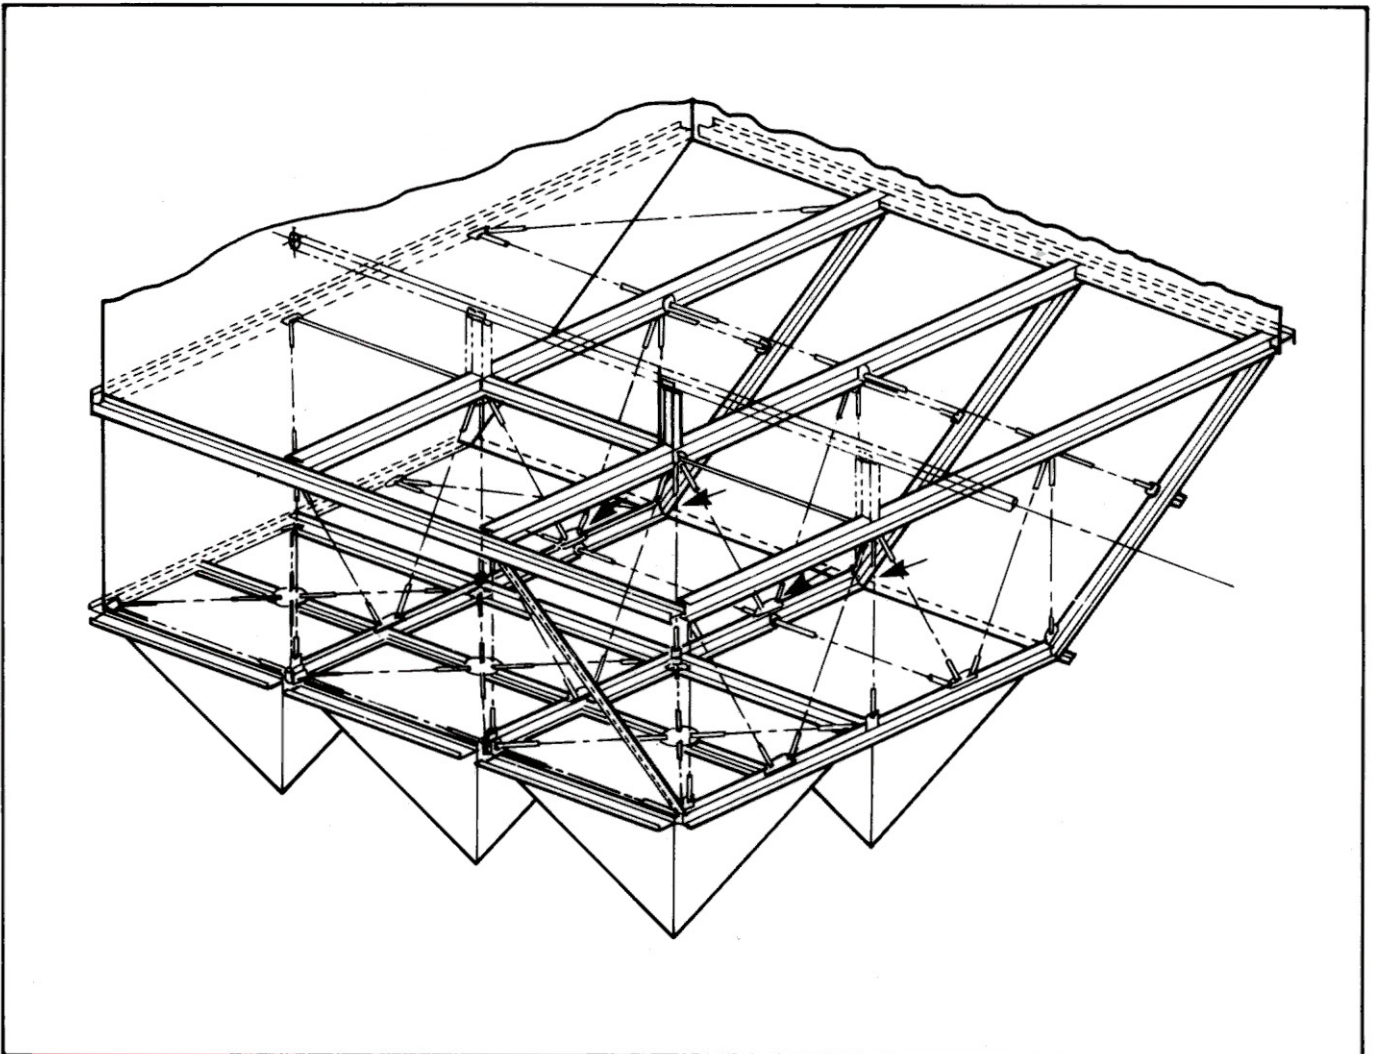
The majority of economizer hopper supports are located internal to the boiler, in the flue gas stream. As such for coal fired boilers, these supports are subject to wear and damage from erosion.

Recent inspections of several boilers have revealed varying degrees of erosion damage to major hopper support members. The weakening or failure of one major support member causes an undesirable redistribution of loading and stress to other members. These additional loads may cause failures of various hopper supports and potentially total failure of the hopper support system. See Figure 1 and 2 for typical hopper arrangements.

**Figure 1** Typical economizer hopper, trusses and supports that may experience erosion damage.

1. Inspect all trusses and gusset plates for erosion and corrosion damage. Pay particular attention to the major support paddles and end supports of the trusses. Repair all affected areas.
2. Check existing ash density and compare to original design values. Discuss any signifi-

cant (more than 10%) deviations with the manufacturer.

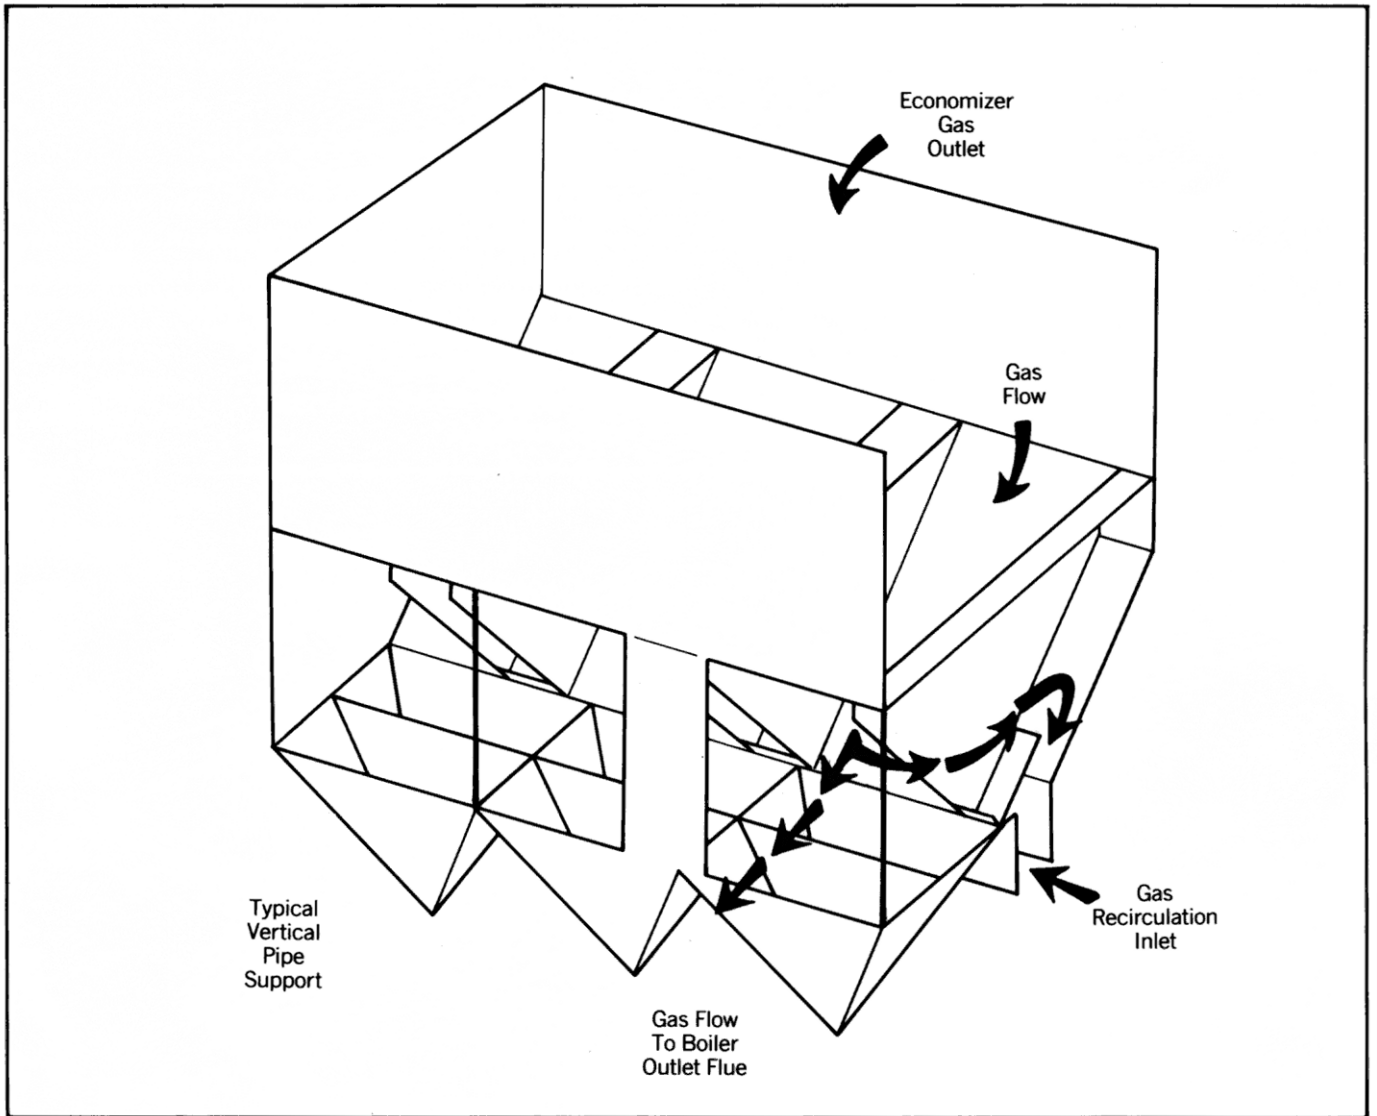
**Figure 2** Typical envelope supported hoppers.

4. Modifications - Field changes made to the design support system without the manufacturer's review and approval could result in higher than anticipated loads for some members of the support system. These changes could include removal of some support members or removal of the gas recirculation envelope plates.

3. Inspect hoppers during operation to make sure they empty properly. Take action to assure the ash removal equipment is operating properly to keep hoppers empty.
4. Keep a record of flue gas temperatures in this area and discuss the significance of any levels higher than design conditions with the manufacturer. Establish a maximum allowable temperature limit for your boiler.
5. Review any changes made to the existing hopper support system or any changes contemplated to the supports with the manufacturer.
