UP Boiler Mix Stud Plate Cracking

Advise customers to inspect for cracks in wall tubes in the furnace enclosure mix areas of UP boilers that were designed prior to 1973. Several recent inspections have revealed stud plate deterioration and cracking, which has propagated into the tube wall, typically at the termination of the stud plate or membrane weld.

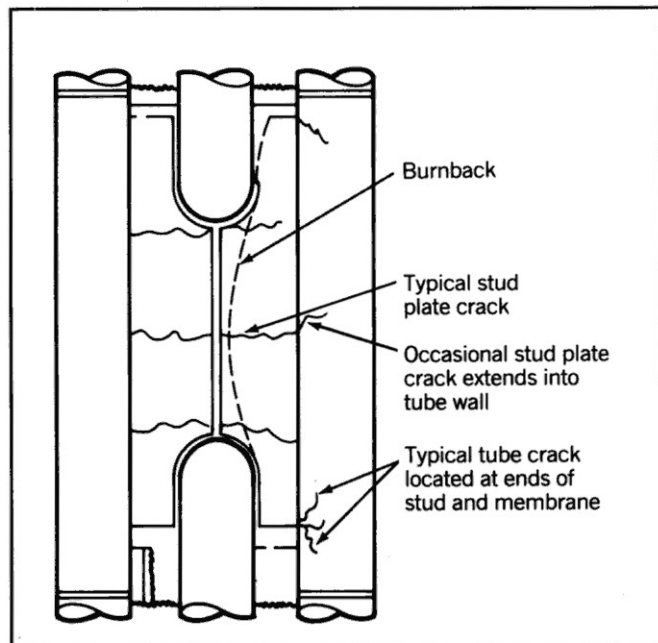
Figure 1 shows the "H" type stud plate design and the typical cracking, which can occur. This cracking can be quite advanced before tube leaks develop and extensive mix area tubing replacement may be required to avoid forced outages for repairs.

Figure 1 Typical "H" type stud plate and cracking that could occur.

Visual and dye penetrant inspections will determine the extent of damage and repairs required. The mix areas should be cleaned on the furnace side by sandblasting.

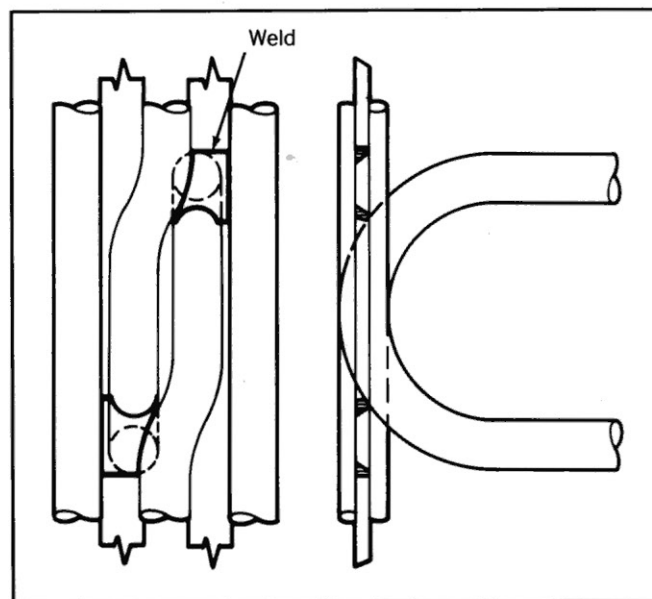
Mixes are required for B&W UP boilers, having up-up circuitry to eliminate fluid flow temperature unbalances and the potential for overheating tubes. To eliminate the cracking problem, B&W developed the all welded mix design in 1973. Figure 2 shows this construction. The all welded mix has proven to be a maintenance-free design, which has been demonstrated on many boilers, including both original and retrofitted equipment.

Figure 2 New all welded mix area.

2. Replace the existing mix tube bend area with the all welded construction as shown in Figure 2. This is the best positive step for completely eliminating the cracking problems as well as the annual refractory repairs necessary with the solution described in 1 above.

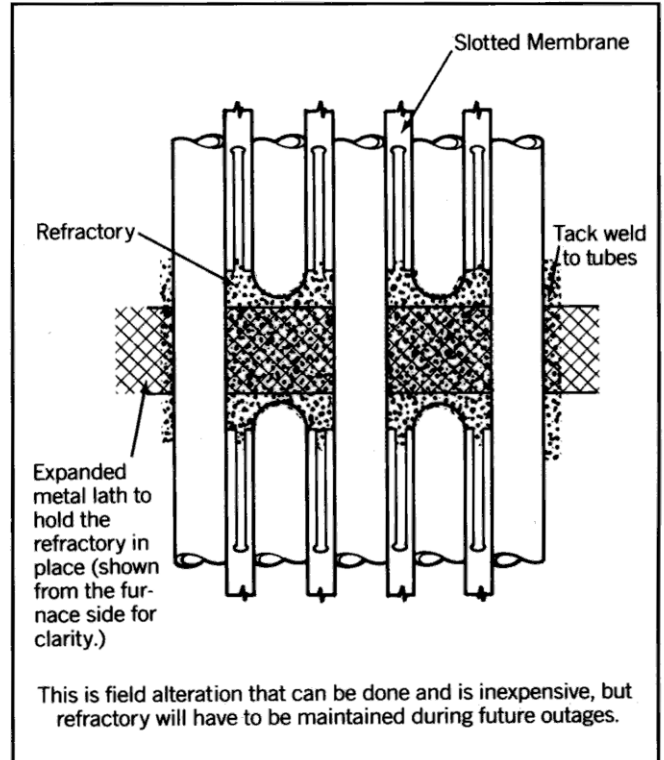
Figure 3 Repair of old design viewed from furnace.

1. Figure 3 shows a repair used for units with relatively minor cracking problems. The existing stud plates are not replaced but they are trimmed to within 1/4" of the tube surface to prevent additional stud plate cracking. Some tube section replacement may be required in areas that exhibit minor cracking. The membrane bar terminations should be inspected and modified, if necessary, to make sure that the membrane-to-tube welds wrap around the ends of the membrane bars and that the weld terminates on the membrane bar. Refractory seals supported by stainless steel expanded metal lath are installed to close the openings in the existing burned back and slotted stud plate. This repair has proven to be effective, but refractory maintenance will be required.
