Steam-Cooled Spacer Tube Related Cracking of Secondary Superheater Outlet Headers

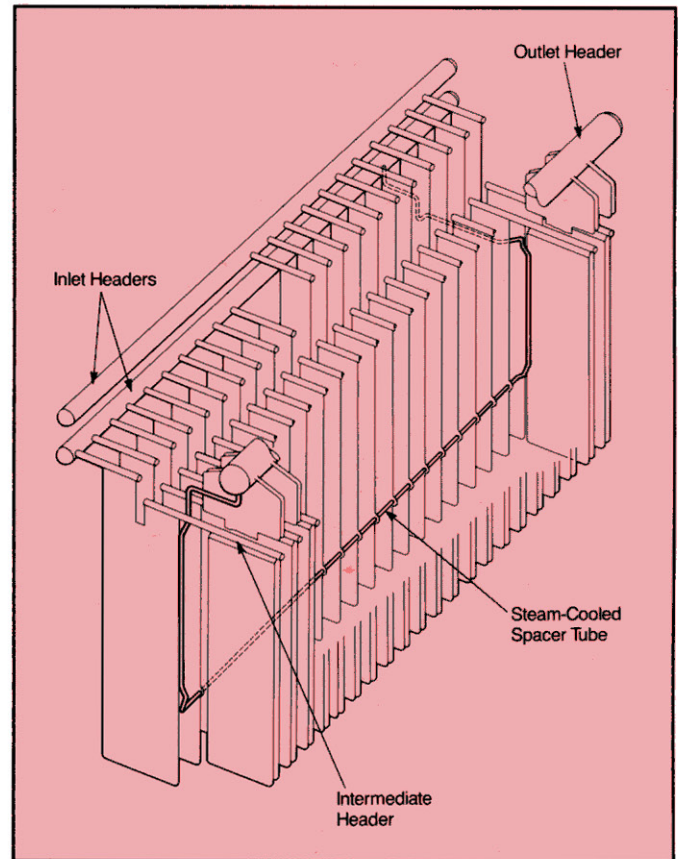
To advise owners and operators of B&W drum and once-through coal-fired design boilers, equipped with secondary superheater steam-cooled spacer tubes, to inspect the secondary superheater outlet header internal surfaces for cracks in the vicinity of the steam-cooled spacer tube entries. The steam-cooled spacer tube design (see Figure 1) is used on many units to maintain superheater section side spacing.

Internal, longitudinal cracks may develop on the inside of the outlet header in the vicinity of the steam-cooled spacer tube entries. These cracks are caused by thermal quenching from water that clears the spacer tube during startup and impinges on the higher temperature outlet header internal surface. Longitudinal-type cracking may also develop in the spacer tube bore holes because of this thermal quenching.

Figure 1 Pendant superheated with steam-cooled spacer tube.

To avoid the quenching and prevent header damage, the spacer tube should be boiled out simultaneously with the secondary superheater before the startup gas temperature limit is released. The following recommendations are provided to determine if header damage is developing on a unit, and to identify the corrective measures to help prevent further damage.
