Convection Pass Lower Header Closure Plate Cracking

This bulletin advises owners to inspect for cracks in closure plates and wall tubes located in the convection pass lower header area of UP and RB boilers.

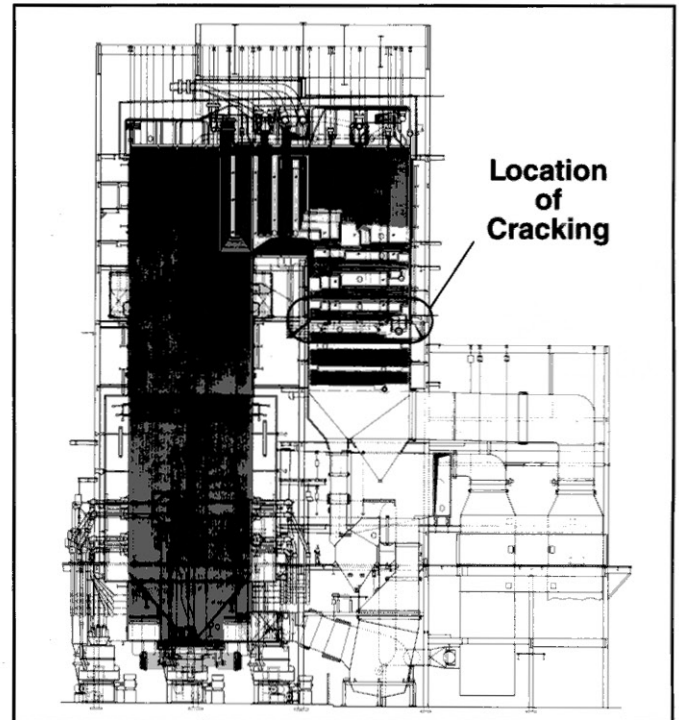
Closure plate cracking has occurred between adjacent lower convection pass headers at membrane panel splits. Figure 1 shows the general location of this cracking. In some cases, cracks have propagated into the tube wall resulting in tube failures. Figure 2 shows the typical closure plate design between headers and an example of the cracking. This cracking is usually quite advanced before tube leaks develop.

Figure 1 Location of closure plate cracking.

A visual inspection from inside the convection pass enclosure should be made to determine if cracking is present and to what extent. If repairs are required, exterior lagging and insulation around the header ends will need to be removed. If the closure plate is cracked, it should be replaced. If cracking has propagated into the tubing, the affected tubing should be replaced.

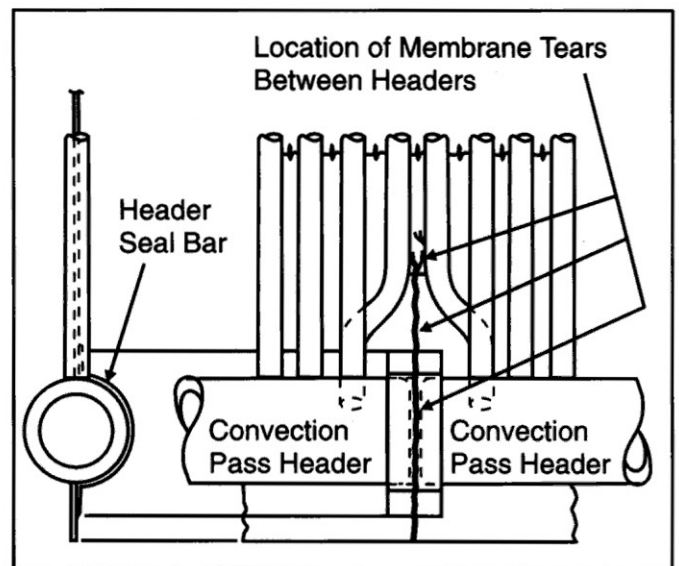
B&W has supplied membrane-tube wall panels with shop-attached, closed-end headers for convection pass enclosures for more than 25 years. Temperature differentials that occur during unit startup or shut-down can result in high thermal stresses, which can cause cracks to form at the closure plate between headers. If cracking is observed, tubing and closure plates should be repaired or replaced. Then, reinforcing bars should be applied (see Figure 3) to limit movement between headers and prevent closure plate crack formation. This modification has proven to be successful on units where crack formation had been experienced.

Figure 2 Typical closure plate with cracking.

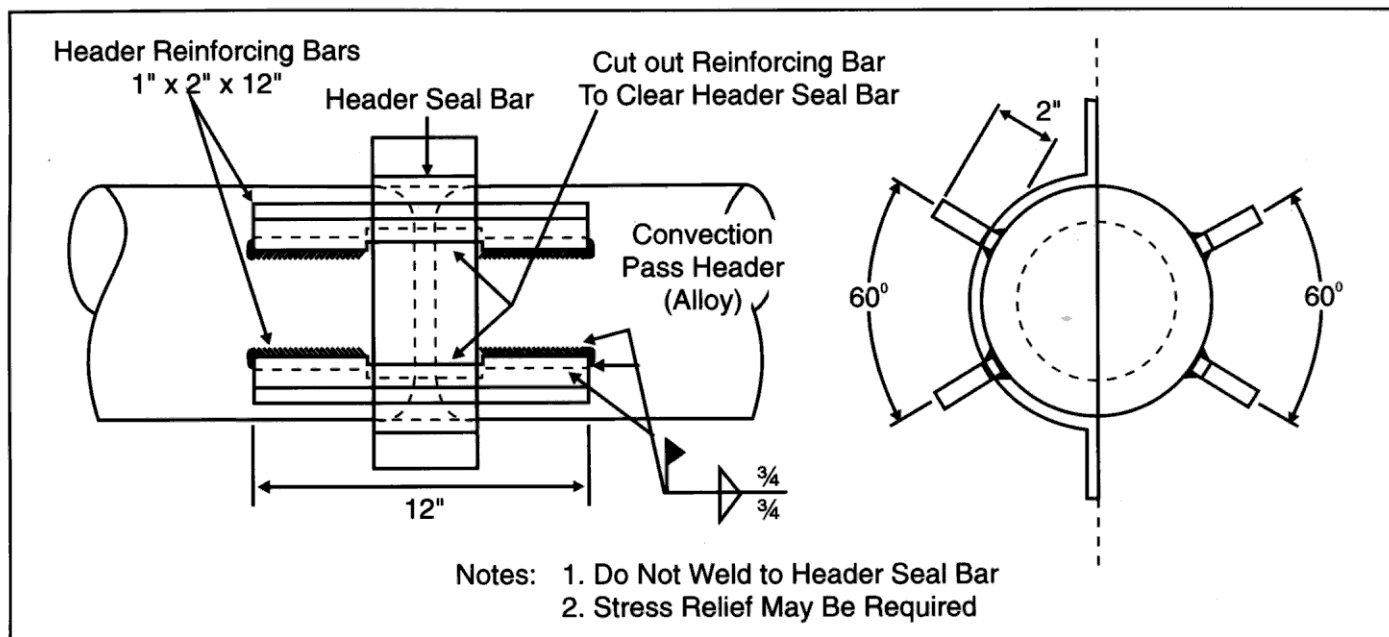
Figure 3 Inlet header reinforcing bars in the convection pass enclosure limit movement between the headers and prevent closure plate crack formation.

As shown in Figure 3, modification to this area requires the addition of four reinforcing bars welded to the headers. (Attempts to weld two reinforcing bars to the headers on the gas side only have not been successful.) Once repaired, the areas should be inspected on a regular basis to assure that the cracking has been stopped.
