Riser and Tube Attachment Fatigue and Corrosion: Location and Evaluation Experience

Technical Service Bulletin

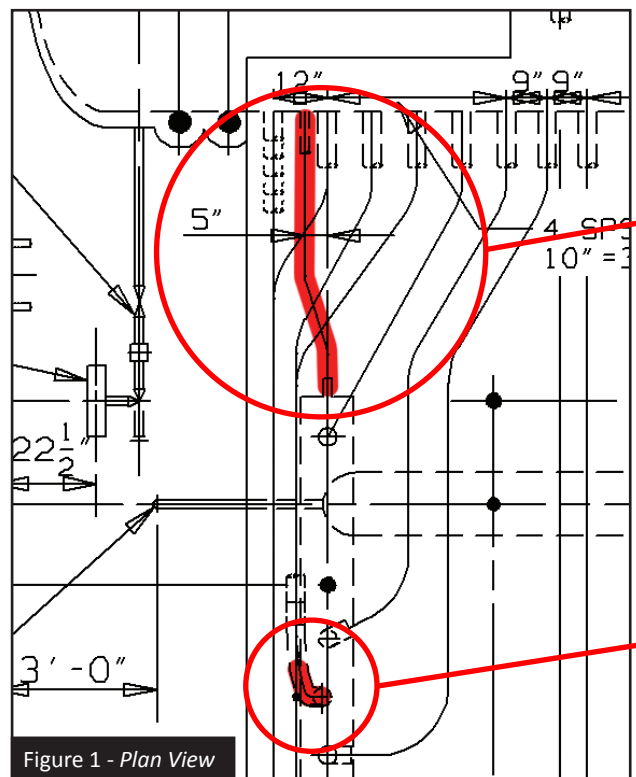
Figure 1 - Plan View

The sidewall outlet header nearest the steam drum has a small, 2 in. diameter relief riser off the end of the header which runs horizontally to the steam drum. The purpose of this connection is to ensure circulation flow in that circuit during transient (startup and shutdown) conditions, recognizing that relatively less heat input to that panel is observed because it passes alongside the nose arch. See Figure 1 plan view, Item 1.

are routed to the steam drum within the penthouse above any screen or superheater headers. A few of the risers bend out of the outlet headers and travel to the steam drum just outside the penthouse enclosure and enter the ends of the steam drum. See Figure 1, Item 2. Other risers are routed inside the penthouse but bend toward the drum within a short distance of the outlet header. See Figure 2 side view, Item 3.

Item 1

Item 2

3. During the next scheduled outage, perform radiographic testing of riser bends, relief risers and attachment weld locations in the penthouse.
4. Visually inspect any tubing removed from the suspected locations for damage.
