Corrosion-Fatigue Failures of Riser Tube Bends

Purpose

This Plant Service Bulletin is a **SAFETY ALERT WARNING** that advises boiler owners and operators of the immediate need to inspect riser and supply tube bends for evidence of corrosion fatigue damage on the inside of these bends and to undertake immediate replacement of damaged tubing.

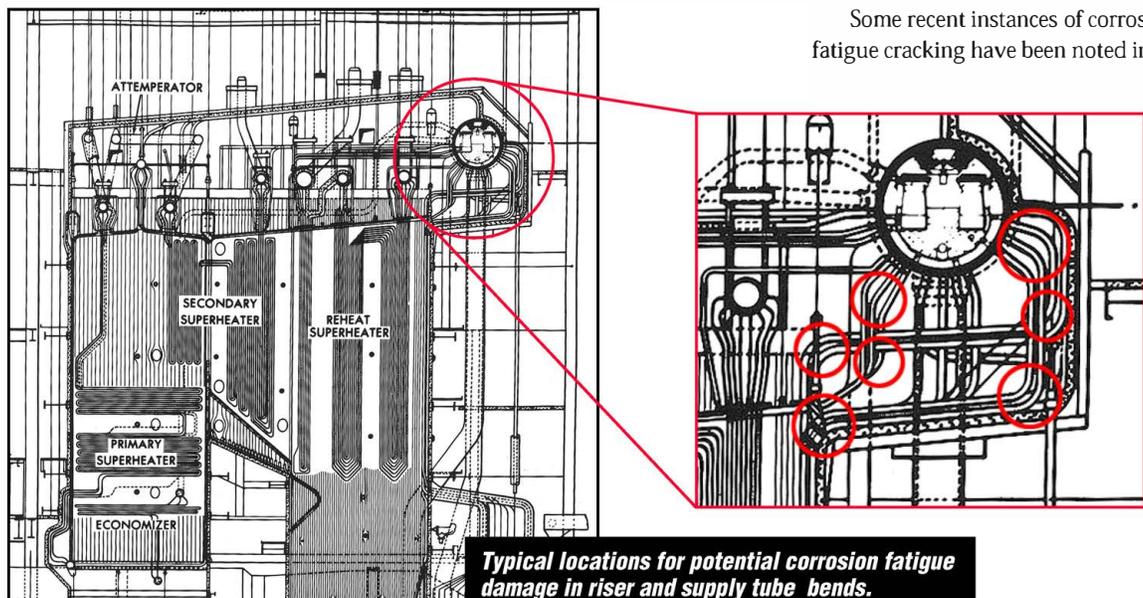
Corrosion fatigue damage has been found on the inside of bends in riser tubes. The damage appears as crack-like indications parallel to the tube axis, predominantly aligned along the neutral axes of these bends, and limited to the bend area. These “cracks” often initiate at internal pitting attack locations and then propagate through the tube wall. In time, pinhole leaks occur that could steam wash and damage nearby tubing and boiler parts. In addition, the leaking tube could catastrophically rupture as a window blowout, ripping along the inside diameter (ID) cracking at the neutral axes. Anyone in the area during such an event could be severely burned or killed.

Typical locations for potential corrosion fatigue damage in riser and supply tube bends.

1. Review boiler arrangement drawings for areas that would be susceptible to pipe and tube flexing during boiler cycling. Pay attention to areas between generally inflexible and rigid penthouse components and the boiler proper. Target these locations first and prioritize those areas as most susceptible to damaging corrosion fatigue.
2. Thoroughly inspect bend areas in riser and supply piping, such as those described above.
3. Review waterside operating history to determine if oxygen, pH or chemical cleaning excursions have occurred. Such excursions would

4. Review pressure part failure history that may indicate increasing susceptibility to corrosion-fatigue failures and revise tube inspection procedures and frequencies accordingly.
5. Replace any tubing that shows any evidence of cracking as soon as possible.

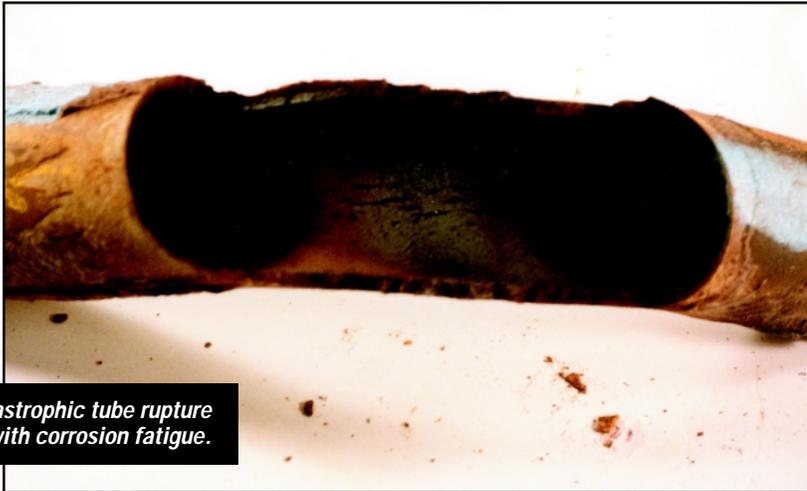
Exposure of water-wetted surfaces to cyclic stress for very long periods of time may lead to the development of internal cracking in the bend areas. Crack initiation and propagation rates can be further aggravated by upset water conditions, especially if combined with repeated acid cleaning operations. Cracking can lead to tube failure, with potential for personal injury and death. In one case, a riser tube rupture pressurized a penthouse that subsequently ruptured casing and injured a nearby worker.

Photo shows catastrophic tube rupture that is possible with corrosion fatigue.
