Plant Service Bulletin

Stress-Assisted Corrosion: Boiler Waterside

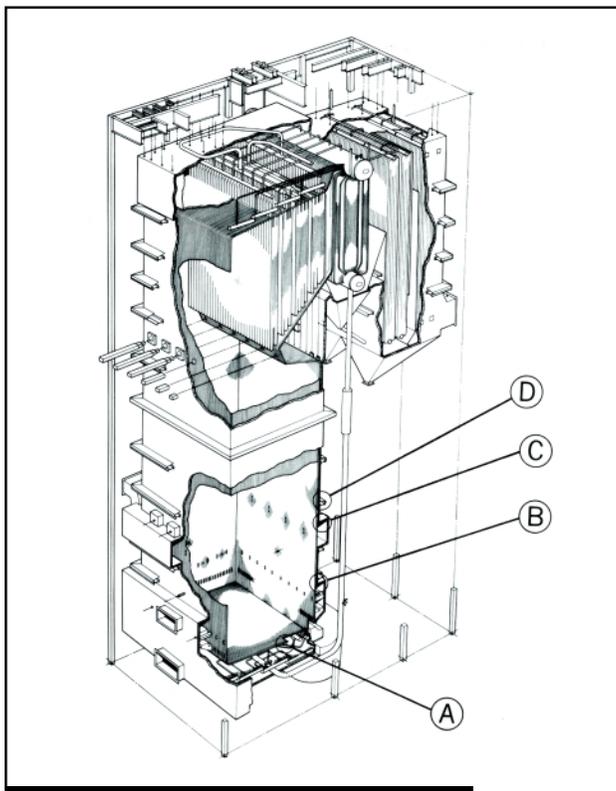
Waterside corrosion in the form of pits, rather than general metal wastage, has been discovered in several process recovery boilers. Corrosion may occur anywhere on the tube surface. Stress-assisted corrosion is more pronounced in the areas of the boiler that are depicted in Figure 1. These include lower side

wall tubes at the floor seal, windbox attachments, buckstay attachments, and riser tube bends. Figures 2 and 3 are macroscopic and microscopic representations of the corrosion that has been observed at windbox attachments.

The corrosion may be oriented in a variety of directions depending on location in the boiler and has penetrated to depths ranging from several mils to over half of the original tube thickness. To date, the most severe damage in membraned boilers has been oriented longitudinally in sidewall tubes at the floor seals.

Figure 1: Welded locations where damage has been found.

4. During the next scheduled outage, carry out x-ray examination of attachment weld locations in the lower furnace. While the potential for corrosion is not believed to be isolated to recovery boilers or to a specific boiler manufacturer, examination of recovery boilers should have a higher priority over other boilers because of the potential for catastrophic damage due to tube failure in recovery boilers.
5. Visually inspect any tubing removed from the suspected locations.

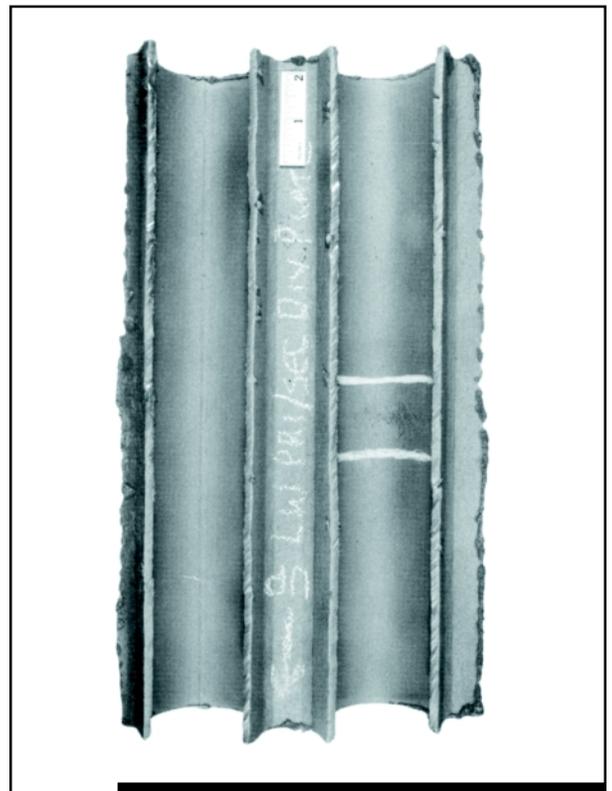
Figure 2: Left sidewall primary/secondary division plate – waterside surface corrosion.

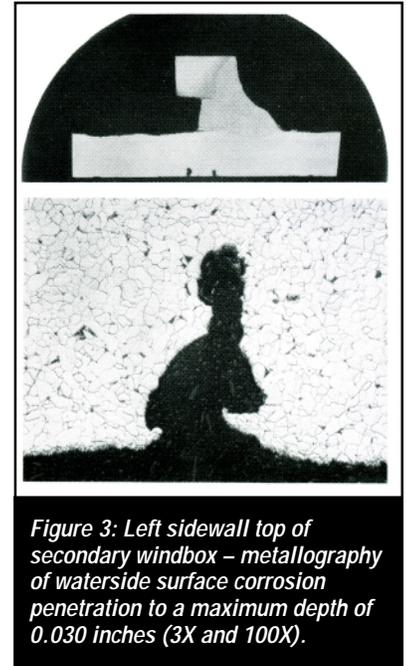
Figure 3: Left sidewall top of secondary windbox – metallography of waterside surface corrosion penetration to a maximum depth of 0.030 inches (3X and 100X).
