Subcooling in Cycling Boilers

This plant service bulletin provides customers with information concerning possible furnace tube failures caused by subcooling in drum type (RB) boilers that are subject to cycling operation and to provide recommendations for preventive action on a particular boiler.

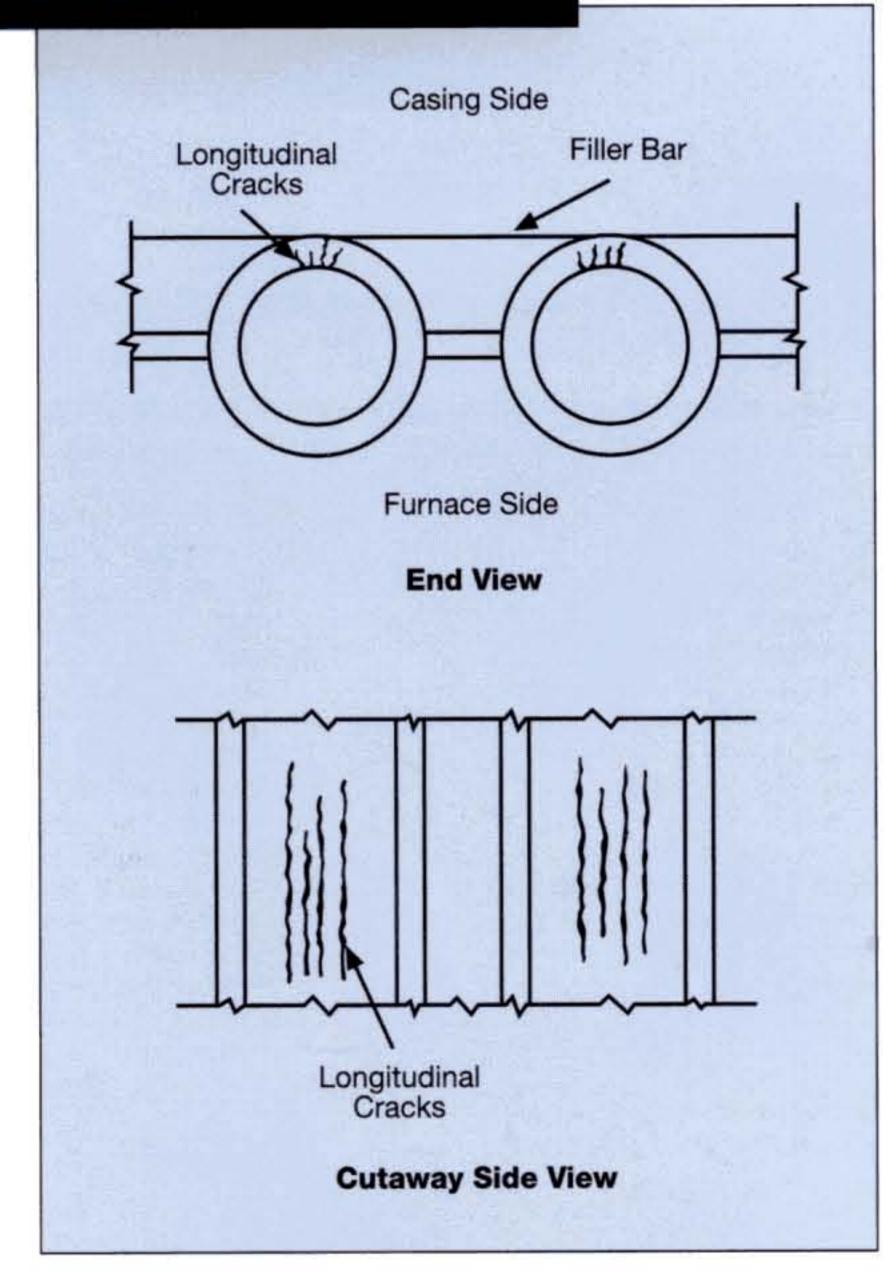
Figure 1: Lower windbox tube failures

Some cycling units experience longitudinal cracking of the lower furnace tubes, particularly adjacent to attachments. The cracks initiate on the inside diameter (ID) surface of the tubes and may not be visible from the outside until the cracks penetrate the complete tube wall. If the cracking goes undetected, a major tube leak problem may develop, requiring extensive lower furnace tube repair or replacement. Figure 1 shows a typical cracking location.

Following shutdowns, the lower furnace generally cools at a faster rate than the upper furnace. Upon starting up, when circulation is reestablished in the furnace tubes, hot water in the windbox area of the furnace is rapidly displaced by cooler water from the lower furnace causing thermal shock to the tubes. The resulting thermal stresses are highest in the areas where the furnace tubes are restrained, such as at the filler bars shown in Figure 1, as well as where other attachments are welded

to the furnace tubes. These are the areas where the most severe problems have been observed. Due to the variety of operating conditions, the extent of the thermal shock experienced varies widely from unit to unit, and can occur in the absence of any weld attachments.

Units that cycle should be tested to evaluate the risk of failure and to determine necessary corrective actions. Detailed inspections should be carried out if test results indicate a problem is likely. The tests should evaluate temperature gradient information during boiler shutdowns and start-ups.

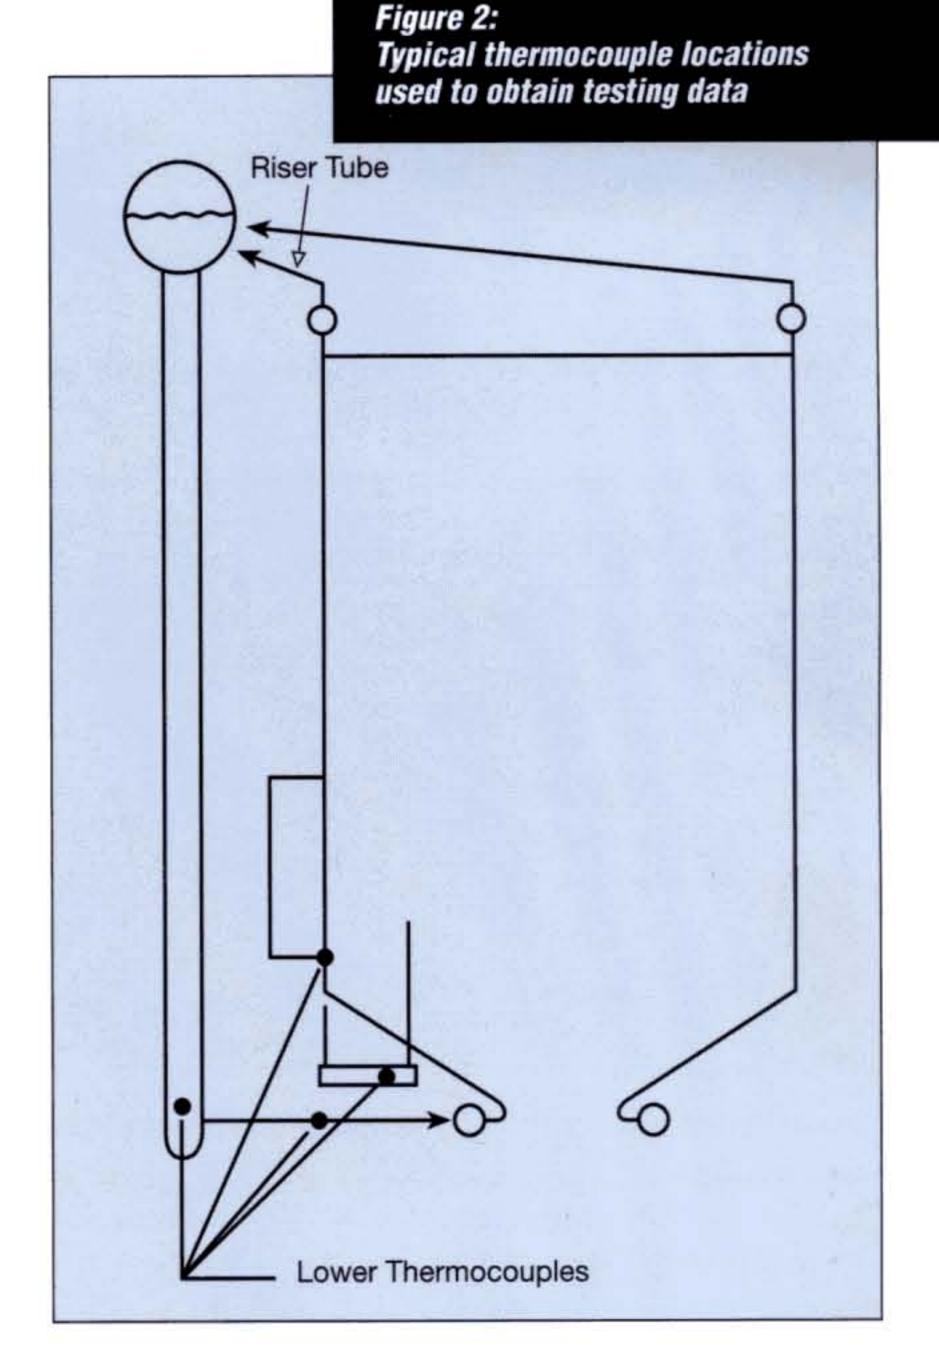
Figure 2 shows the typical locations of thermocouples in the lower furnace and on riser tubes, which

are used to obtain the required data. For consistency and proper interpretation of the data, readings should be obtained from at least four (4) overnight and two (2) weekend shutdowns. An engineering evaluation of the data is required to assess the data and develop a recommended course of action.
