Spray Attemperators

The purpose of this bulletin is to advise customers and field personnel about superheater attemperator problems and provide recommendations for corrective action.

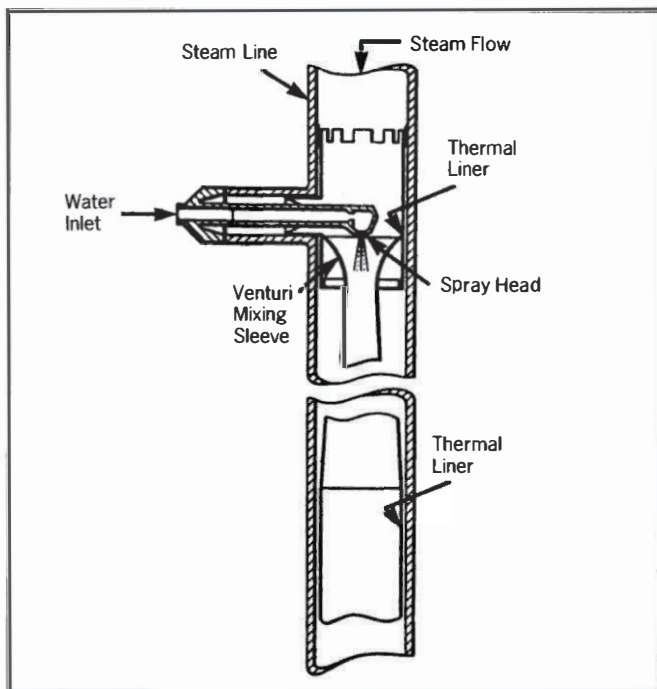
Figure 1 Spray attemperator.

The first B&W spray attemperator went into service in the mid 1950s. Since that time, design improvements have been made to extend attemperator life. These include adding a thermal sleeve and a material change. Figure 1 shows an early design attemperator.
