Riser and Tube Attachment Fatigue and Corrosion: Location and Evaluation Experience

Technical Service Bulletin

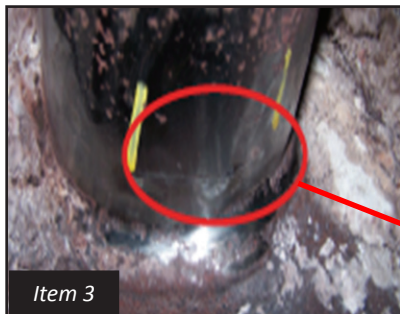
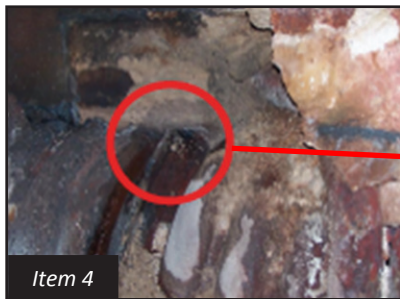
To date, radiographic testing is the only proven non-destructive technique that provides positive detection of corrosion damage. Other non-destructive examination methods are under investigation for characterizing the extent and depth of corrosion damage.

3. During the next scheduled outage, perform radiographic testing of riser bends, relief risers and attachment weld locations in the penthouse.
4. Visually inspect any tubing removed from the suspected locations for damage.
